**Camden County Department of Public Works  
Division of Engineering  
Superstructure Repairs for Cuthbert Boulevard (CR 636) Bridge and  
Grove Street (CR 644) Bridge over Cooper River  
Camden County, New Jersey  
Weekly Progress Report No. 5  
September 7, 2018 to September 14, 2018**

**Weekly Progress Report No. 5: 9/7/18 – 9/14/18**

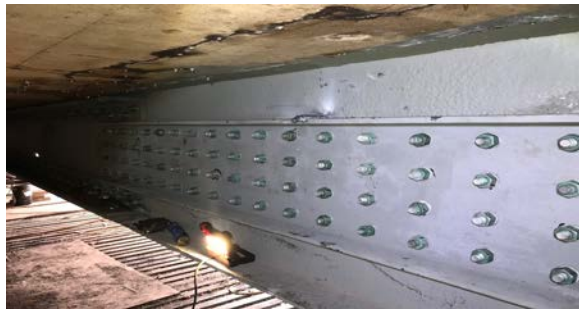
*Figure 2: Grove St. Bridge Installation of Structural Steel Channel Beam G-8*

South State Inc. (SSI) subcontractor continues to install remainder of structural steel repairs to existing steel beams as per plan. Crew used fork jack lifts equipment to raise materials from work platform into position at individual beams. Crew slid proposed steel channels and angles from lifts to mount to existing beams. Once clamped in position workers then used mag-drill to drill holes into existing steel beams matching proposed steel repairs. Crew finished installation of repair material to G-3. While G-3 was being installed two ironworkers started drilling steel at G-9 and G-8. Once additional holes were drilled, crew started installing bolts. At days end on Friday the 14<sup>th</sup> of September all steel repairs have had bolts installed. Crew then started with Skid Moore test and bolt torque, however due to weather conditions crew postponed test and torque till Monday.

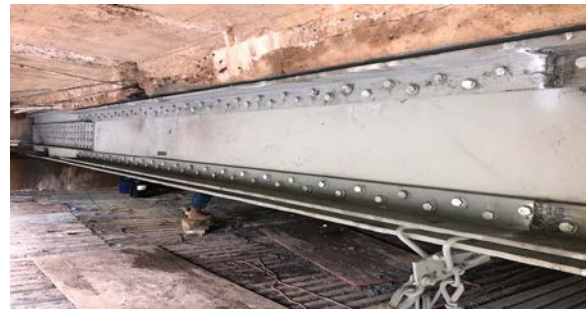
*Figure 3: Grove St. Bridge Installation of Structural Steel Channel Beam G-9*
