**Camden County Department of Public Works
Division of Engineering
Superstructure Repairs for Cuthbert Boulevard (CR 636) Bridge and
Grove Street (CR 644) Bridge over Cooper River
Camden County, New Jersey
Weekly Progress Report No. 6
September 14, 2018 to September 21, 2018**

Weekly Progress Report No. 6: 9/16/18 – 9/22/18

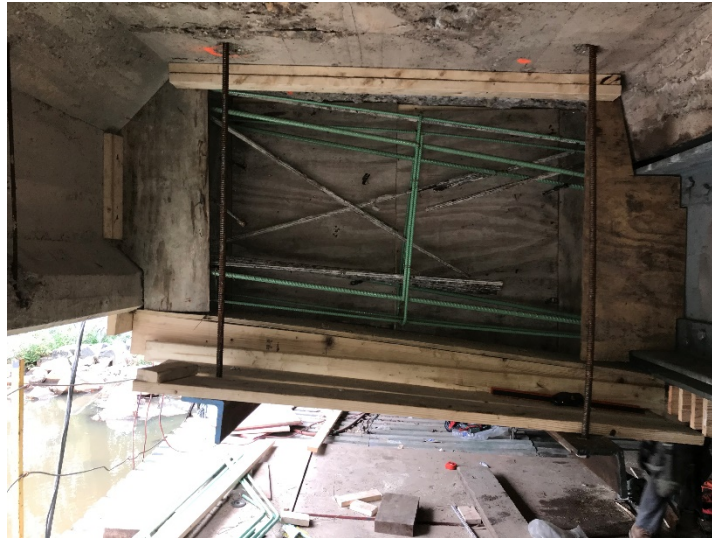
Figure 1: Grove St. Bridge – Rebar and Formwork between G9 and G8

Structural Steel Repair angles are approved. SSI carpenters arrived at Grove Street Bridge and started construction of forms for concrete diaphragm replacement. Carpenters completed installation of rebar for concrete diaphragms on G10 to G-9 N and S, G-9 to G-8 N and S and G-8 to G-7 N and S. SSI sent laborer to do core drilling for bracing of forms and also core drilling for concrete pour of new diaphragms. Carpenters completed building forms for diaphragms leaving only G-9 to G-8 North and G-8 to G-7 North, core drilling was not completed in those areas and will return the following week to complete. Detour remains in place and police in position at bridge with twenty-four (24) hour shift and an officer at Maple on an eleven (11) hour shift Monday – Friday only. SSI has concrete construction barrier at bridge as per plan. Traffic Control Truck with Crash Cushion in position at south abutment. All MPT devices are in place.

SSI carpenters will complete core drilling and remaining forms for concrete diaphragms and also place concrete on Tuesday for diaphragm repairs for G10 to G-9 N and S, G-9 to G-8 N and S and G-8 to G-7 N and S weather permitting.

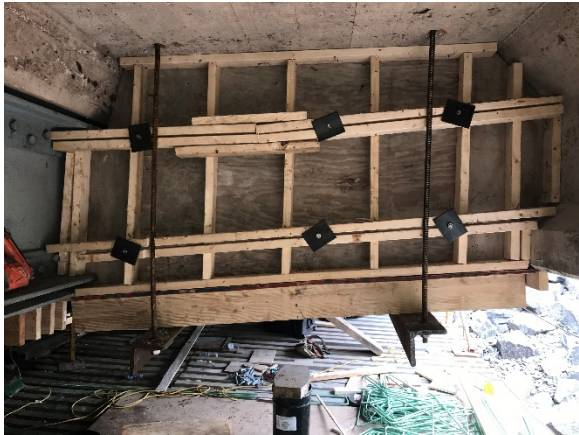
Figure 2: Grove St. Bridge Formwork between G8 and G9

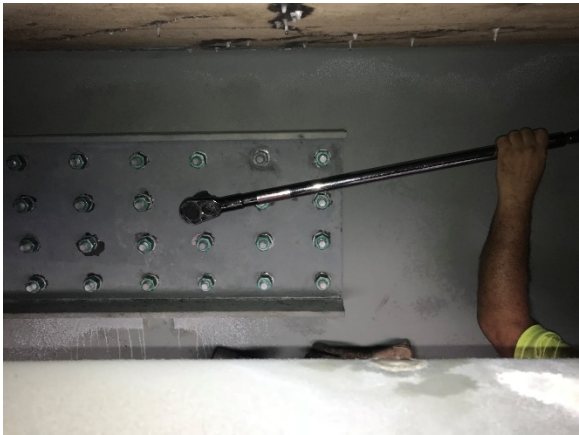
Figure 3: Grove St. Bridge Bolt Testing

South State Inc. (SSI) steel subcontractor completed installing bolts to Structural Steel Repairs on Friday 9/21/2018. SSI steel subcontractor performed the Skidmore-Wilhelm tension test as per NJDOT S-3 and will generate report. Steel subcontractor also completed torque testing bolts on Structural Steel Repairs on G-9, G-8 and G-3 subcontractor set torque wrench to 450 ft/lbs. and torquing each individual Structural Steel Repair before proceeding to next section. Steel subcontractors removed all of their tools and materials from site and will return when additional
