**East Atlantic Avenue (C.R. 729)
over Nicholson Road (C.R. 635)
Bridge Replacement Project**

*Borough of Audubon
County of Camden, New Jersey
Weekly Progress Report
Monday 03/12/2018 thru Friday 03/16/2018*

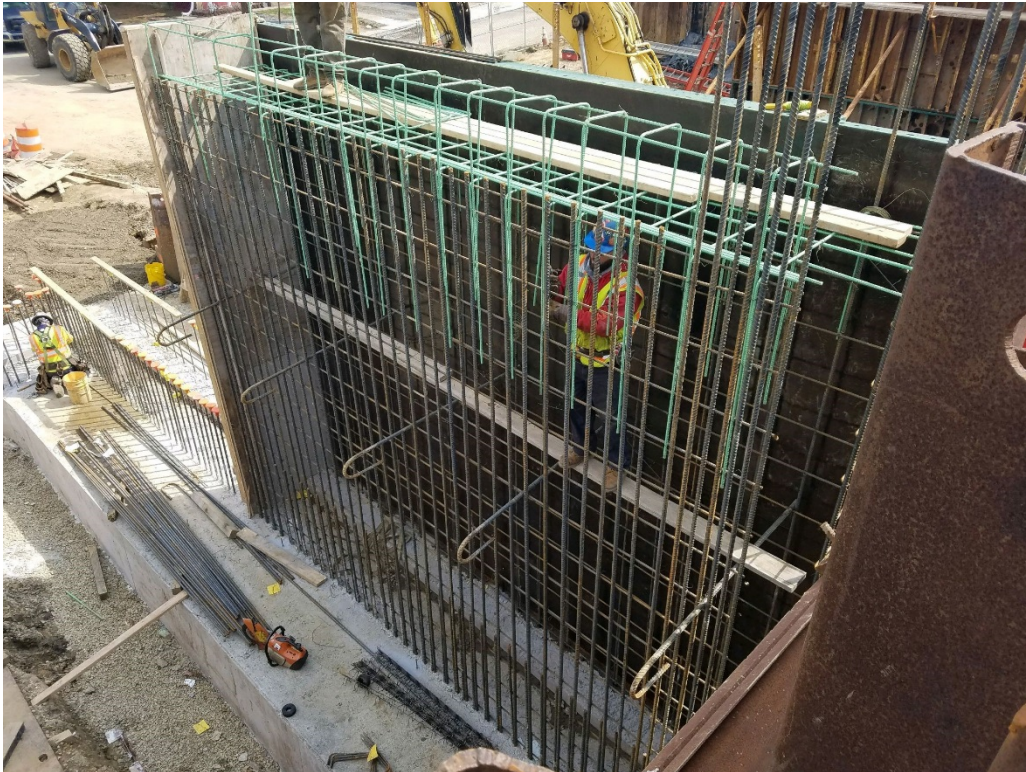
Figure 1
L&R Construction Installing Rebar on Abutment Wall.

RE Pierson's subconsultant, L&R Construction was on site from Monday through Thursday installing the rebar for the Abutment Walls.

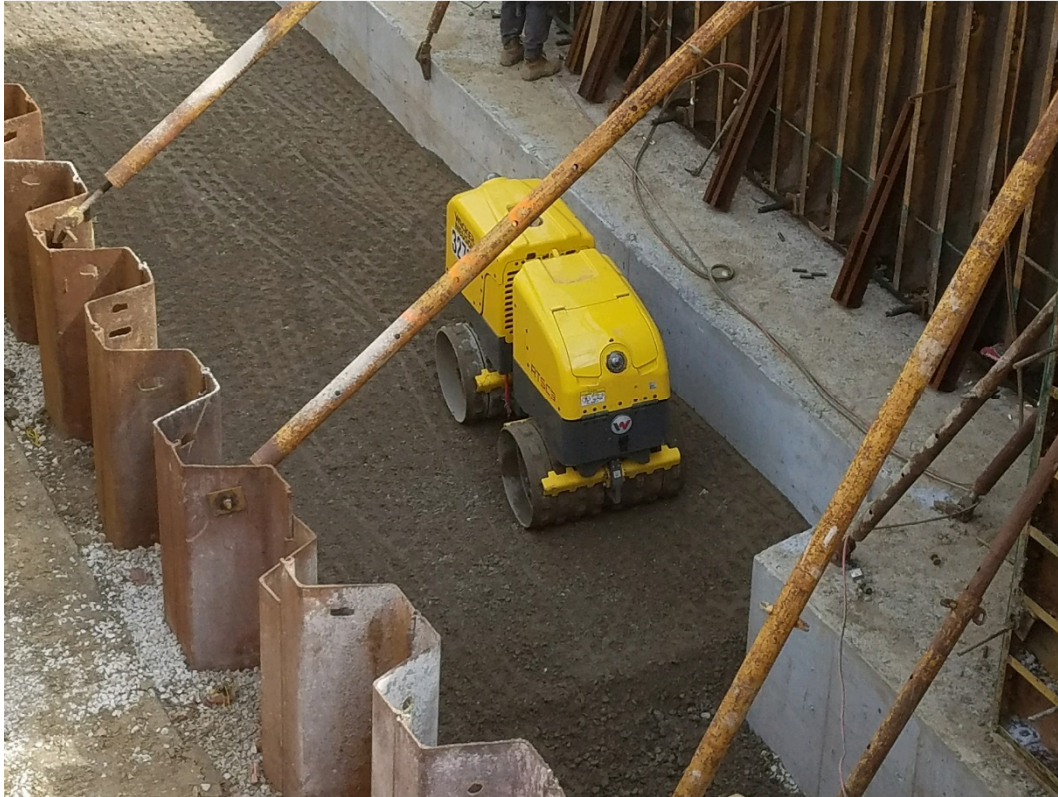
Figure 2

RE Pierson compacting DGA in the area between the Temporary Sheet piling and South Abutment with a roller

On Thursday, March 15, 2018, RE Pierson backfilled area between temporary sheeting and north abutment footing with No. 57 Stone. Additionally, the area between the temporary sheeting and South Abutment was backfilled with DGA and compacted with a roller. T&M was on-site during the backfilling and compaction.

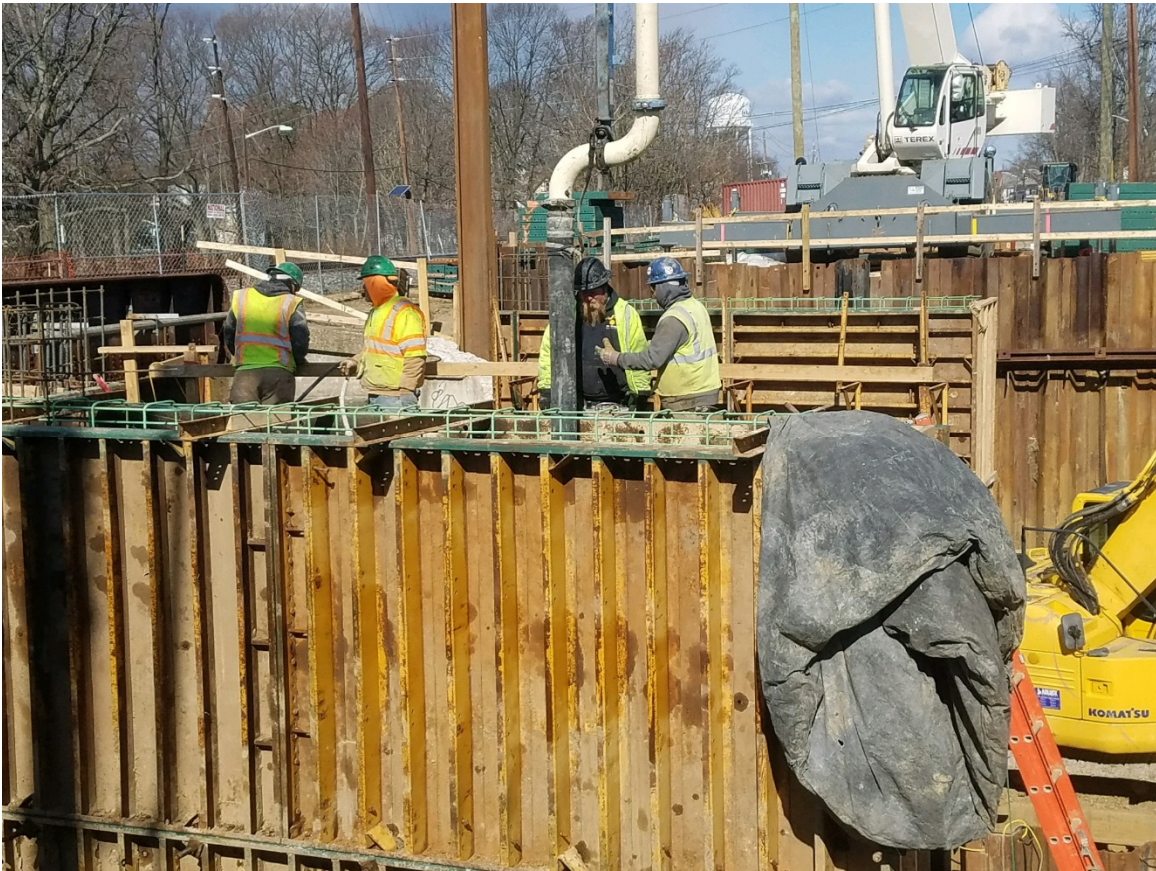
Figure 3

RE Pierson preparing pouring concrete at South Abutment Wall

RE Pierson placed 64 CY of Concrete, Class B with Visocrete 1000 Super P to complete the west half of the South Abutment. Craig Testing was on site performing concrete testing on the first load of Concrete poured for the South Abutment. Air Entrainment was tested on the first load and was measured at 3.8% which did not meet specifications. Contractor added air, and Air Entrainment second load was tested as 5.8%, meeting specifications. Testing was performed on the first load and fourth loads for the South Abutment. In total, 9 cylinders were taken. Testing results are as follows:

- First Load (after Air Added) - Air Entrainment = 5.8%; Slump = 4.5"
- Fourth Load – Air Entrainment = 7.2%; Slump = 8"
