East Atlantic Avenue (C.R. 729) over Nicholson Road (C.R. 635) Bridge Replacement Project

Borough of Audubon County of Camden, New Jersey Weekly Progress Report Monday 03/26/2018 thru Friday 03/30/2018

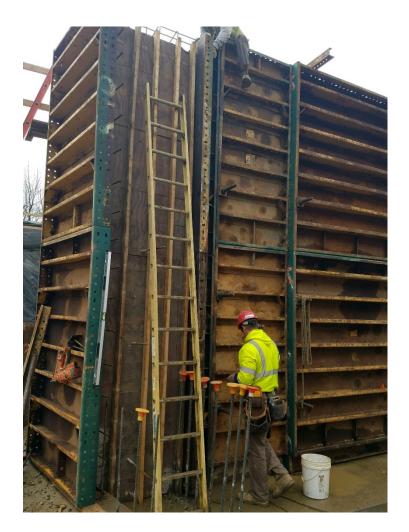
**Figure 1** *RE Pierson installing formwork at SE Abutment Wall*

RE Pierson continued installing formwork and bracing at SE Abutment Wall. On Tuesday, March 27, 2018, RE Pierson placed 47 CY of Concrete, Class B with Visocrete 1000 Super P to complete the Southeast Abutment Wall. Craig Testing was on site performing concrete testing on the first load and fourth load of Concrete poured for the Southeast Abutment Wall. In total, 18 cylinders were taken. Testing results are as follows:

RE Pierson covered Southeast Abutment Wall formwork and top of concrete with thermal blankets, installed heater hoses and turned heater on at the end of the shift.

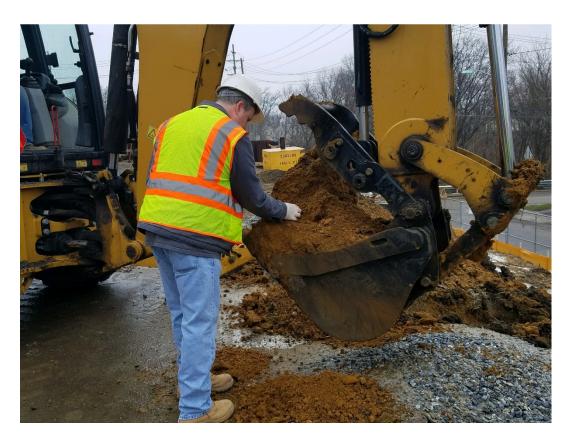
Figure 2

Earth Engineering taking a soil sample at proposed T-Wall location

Frank of Earth Engineering took soil samples at 2 locations of proposed T-Wall, per contract documents.

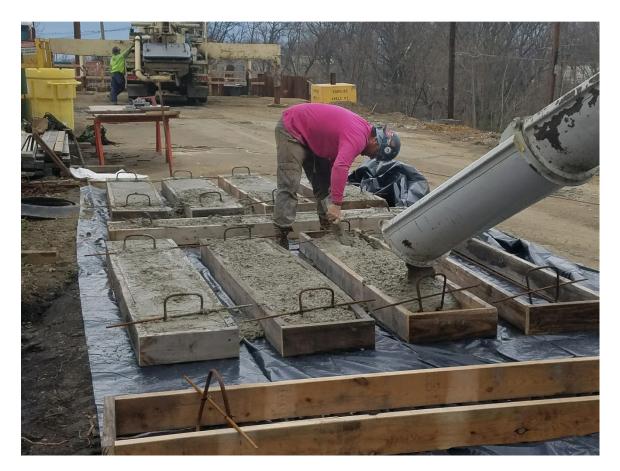
Figure 3

RE Pierson placing concrete into formwork for leveling pads of T-Wall
